**ENVIRONMENTAL PROTECTION AGENCY
TECHNICAL ENFORCEMENT SUPPORT
AT
HAZARDOUS WASTE SITES**

**FINAL
RCRA FACILITY ASSESSMENT REPORT
FOR
ARMCO, INC.
KANSAS CITY, MISSOURI
U.S.EPA SS/ID NO. MOD007118029
U.S. EPA REGION VII**

**WORK PERFORMED BY:
TETRA TECH, INC.
10 CAMBRIDGE CIRCLE DRIVE
SUITE 130
KANSAS CITY, KANSAS 66103
(913) 621-6041**

January 14, 1992

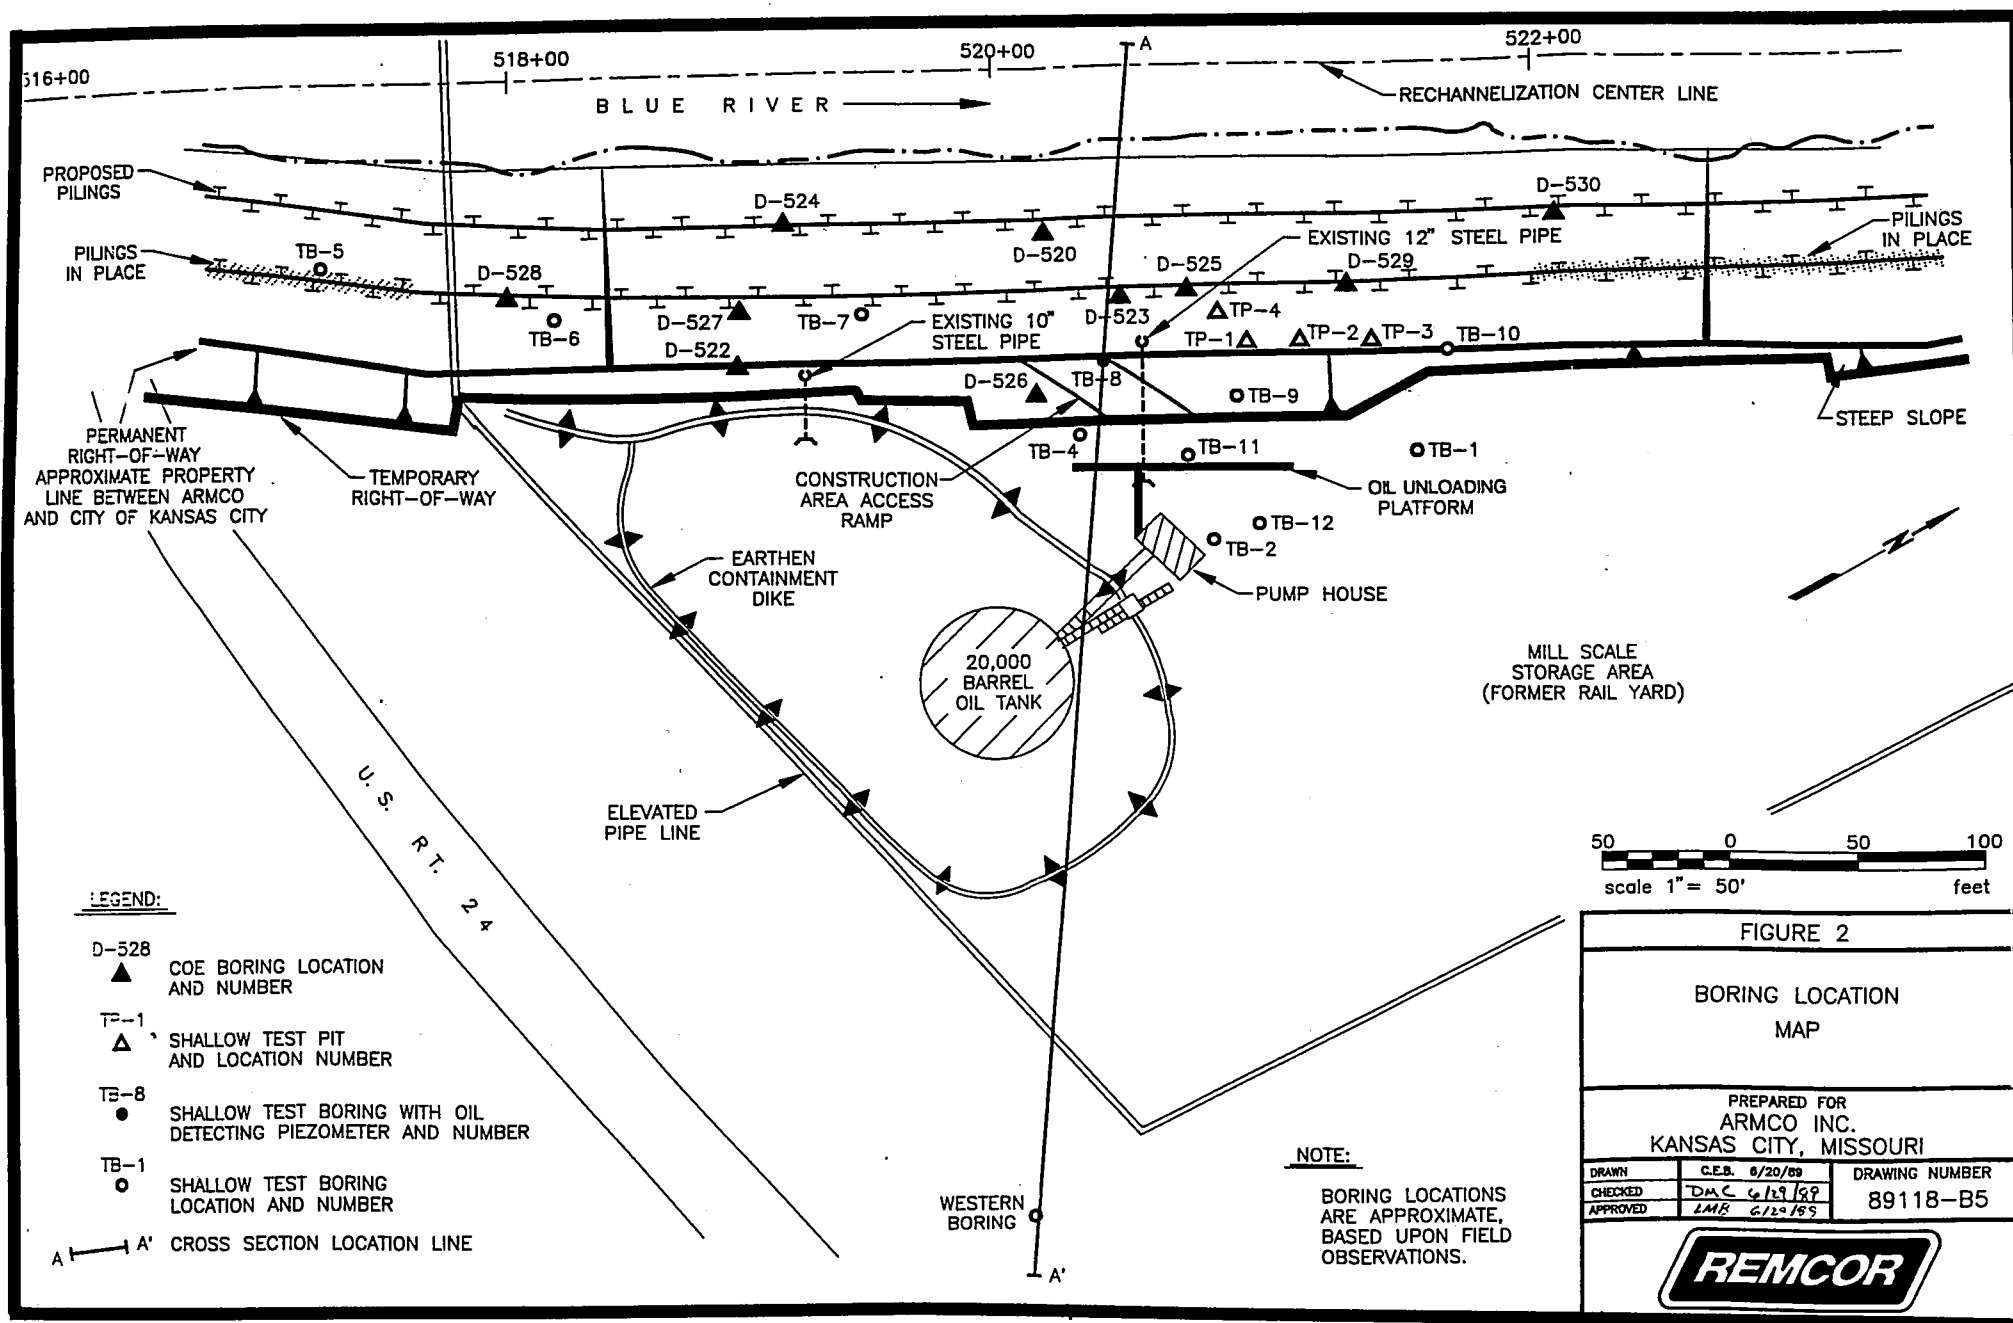
Figure 7: Boring Location Map for AOC No. 1
Abandoned Fuel Oil Storage Tank Area (Ref. No. 63).

tion diagrams, the two observation wells are 22 feet deep and the recovery well is 18 feet deep. The wells were drilled in December 1989, and have 10 foot 0.020 slot PVC screens set at the bottoms of the wells. The piezometer is constructed so that a second casing sits within the first, and is filled only by water from the bottom of the screened interval. In theory, if there is a distinct hydrocarbon layer floating on top of the water, then it would not enter this second casing, thus a difference in water levels in the two casings would indicate the thickness of the hydrocarbon layer.

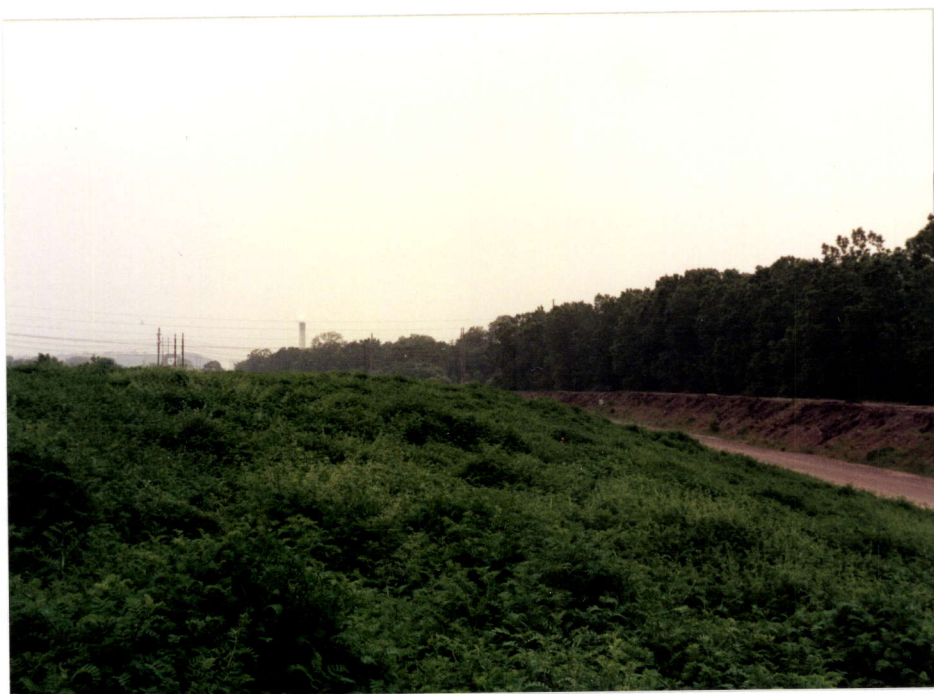
Between 1980 and 1983, the dust was disposed in two trenches along the Blue River (Photo No. 5); these trenches were closed as a RCRA landfill in 1984. A 1,400 yd^3 waste pile was discovered in 1987, and an amended Notification of Hazardous Waste Site was filed by ARMCO. This waste pile was removed in 1988, and no visible evidence remains of its existence (Photo No. 4). Between 1983 and 1986, dust generated at the facility was stored in four RCRA permitted storage tanks. Since 1986, the dust has been loaded directly into railcars and shipped to the Horsehead Resource Development Company, Inc. (formerly New Jersey Zinc) recycling facility in Palmerton, Pennsylvania for recovery of the zinc contained in the dust. According to the 1986 CEI, several railcars of dust were shipped to an unnamed zinc recovery facility in Monterey, Mexico, but the expense was prohibitive and shipping to that facility was discontinued.

Photograph Number : 5
Photograph Date: 5/20/91
35mm; 400 ASA; Speed: Automatic
Photograph Subject: SWMU No. 1: RCRA Landfill.

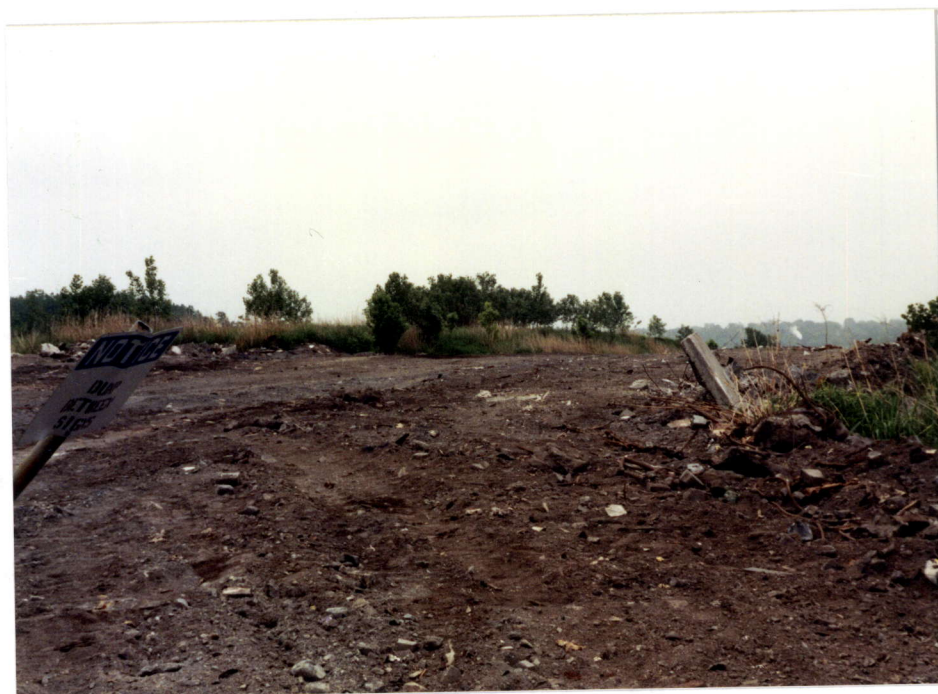
Photograph Number : 6
Photograph Date: 5/20/91
35mm; 400 ASA; Speed: Automatic
Photograph Subject: SWMU No. 5: Rubble Landfill (LF-1).

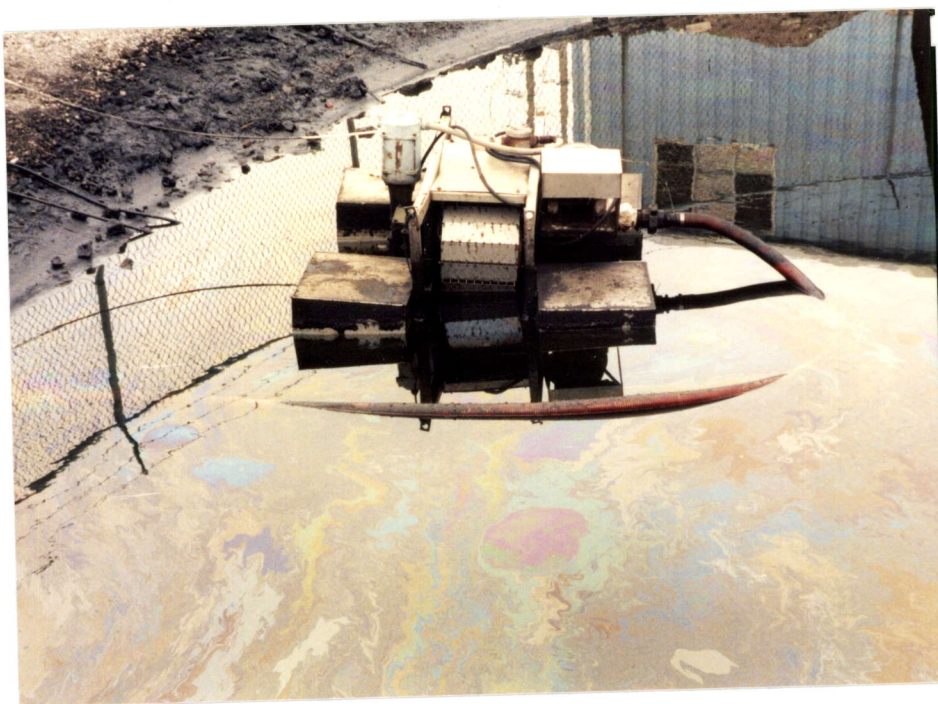
Photograph Number : 8
Photograph Date: 5/20/91
35mm; 400 ASA; Speed: Automatic
Photograph Subject: SWMU No. 22: Mill pond with oil sheen around nonfunctioning oil skimmer.

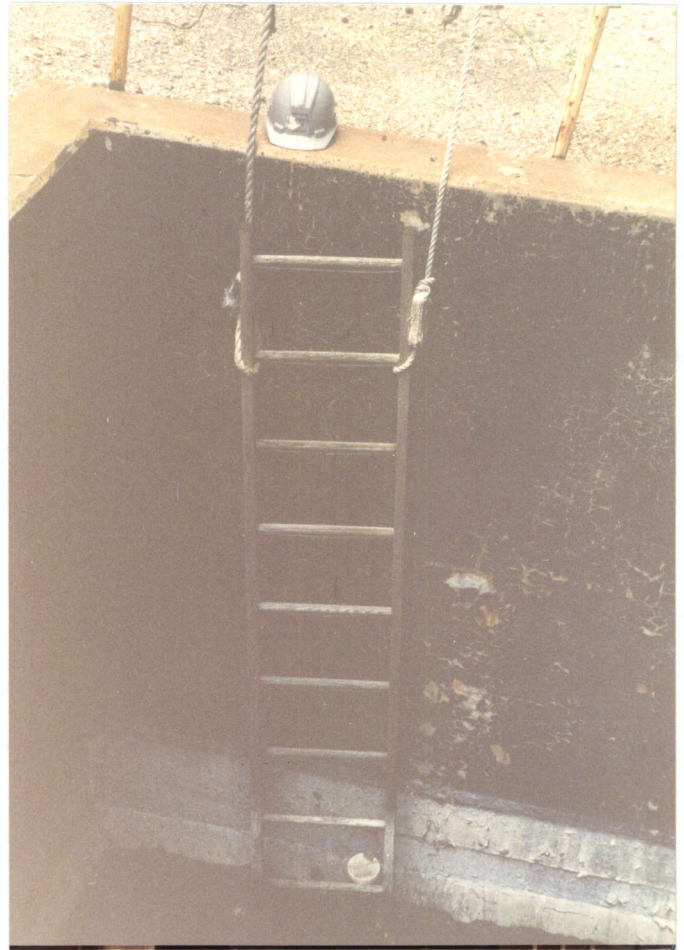
Photograph Number : 11 ➡
Photograph Date: 5/20/91
35mm; 400 ASA; Speed: Automatic
Photograph Taken by: Jenna Mead
Photograph Time: 1357 hours
Direction of Photograph: West
Photograph Subject: SWMU No. 17:
Wire Mill rinsewater neutralization
tank (STU-5).

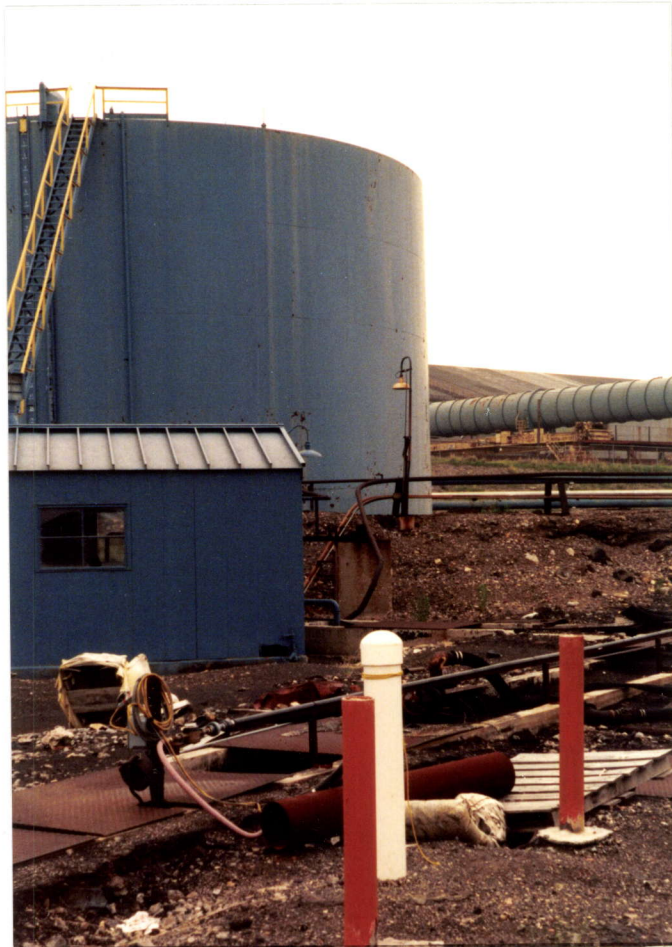
- h. Hydrocarbon spillage or leakage from stored product tanks is known to exist in two cases. An above ground fuel oil storage tank located on the east bank of the Blue River just north of Highway 24 has been identified as the source of hydrocarbon contamination found in soil samples collected along the adjacent river bank by the Corps of Engineers (COE). This 840,000 gallon steel tank (background of Photo No. 12) was installed in 1951, and used for storage of No. 6 fuel oil from 1951 to 1962, and No. 2 fuel oil from 1962 to 1982 when it was removed from service. Since 1982, it has not been used. ARMCO's consultant, Remcor, found 1.5 feet of oil-saturated soil and 1.5 inches of free product (Ref. No. 63). Remcor concluded that the contamination occurred due to historic spillage rather than to leakage of the tank. However, all of the soil borings were around the oil loading platform area, so this hypothesis cannot be evaluated. A recovery well, two observation wells, and an observation piezometer have been installed between the tank and the Blue River (Photo No. 12).

◀
Photograph Number : 12
Photograph Date: 5/20/91
35mm; 400 ASA; Speed: Automatic
Photograph Taken by: Jenna Mead
Photograph Time: 1407 hours
Direction of Photograph: South
Photograph Subject: AOC No. 1:
Abandoned Fuel Oil Storage Tank
Area. Recovery well, pump and
piezometer location.

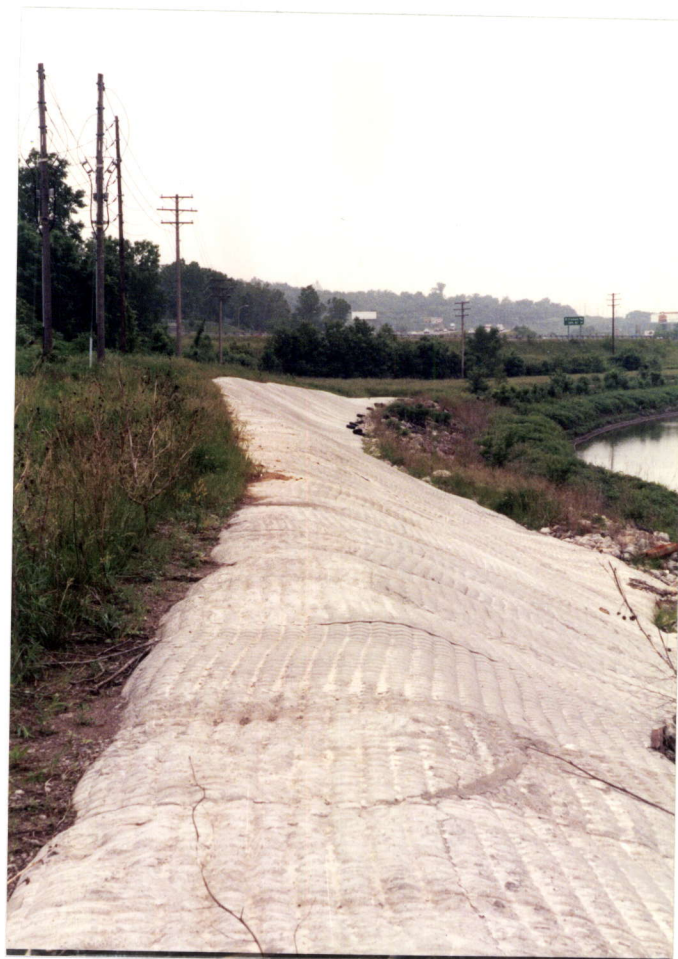
Photograph Number : 17 ➡
Photograph Date: 5/20/91
35mm; 400 ASA; Speed: Automatic
Photograph Taken by: Jenna Mead
Photograph Time: 1423 hours
Direction of Photograph: South
Photograph Subject: SWMU No. 3:
South of Bar Fab Landfill showing
concrete cap along Blue River.

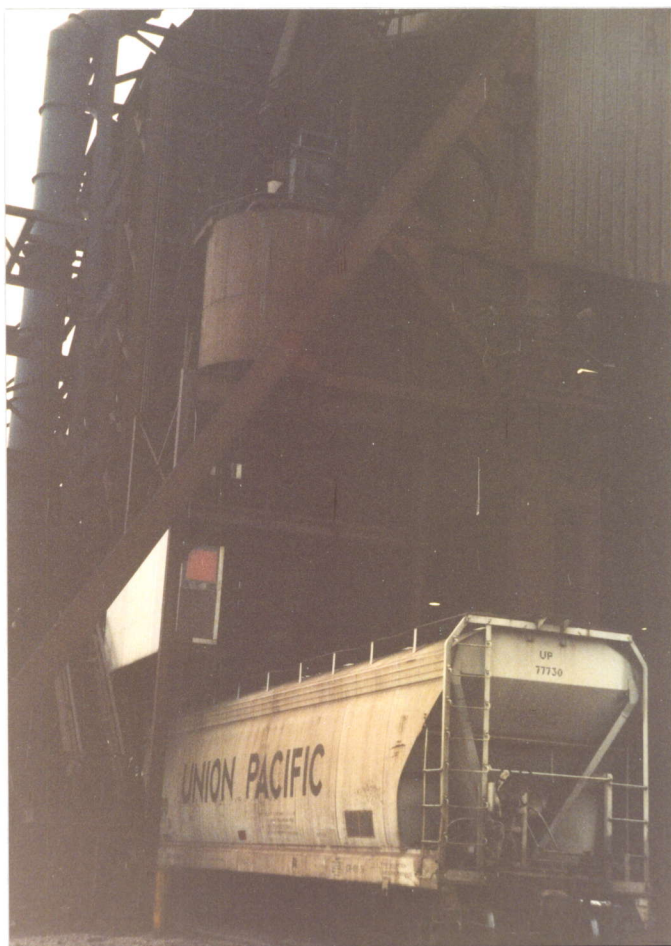
◀
Photograph Number : 18
Photograph Date: 5/20/91
35mm; 400 ASA; Speed: Automatic
Photograph Taken by: Jenna Mead
Photograph Time: 1548 hours
Direction of Photograph: East
Photograph Subject: SWMU No. 8:
No. 2 Melt Shop dust storage tank,
and SWMU No. 11: dust railcar
loading area.

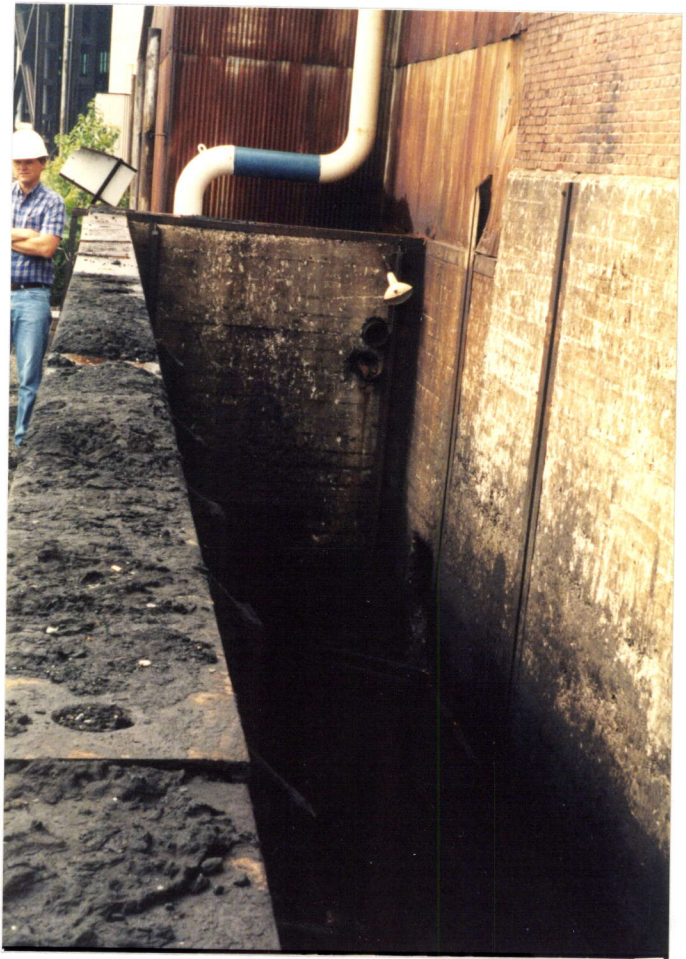
Photograph Number : 19 ➡
Photograph Date: 5/21/91
35mm; 400 ASA; Speed: Automatic
Photograph Taken by: Jenna Mead
Photograph Time: 0958 hours
Direction of Photograph: South
Photograph Subject: SWMU No. 19:
Twelve Inch Mill scale pit (STU-2).

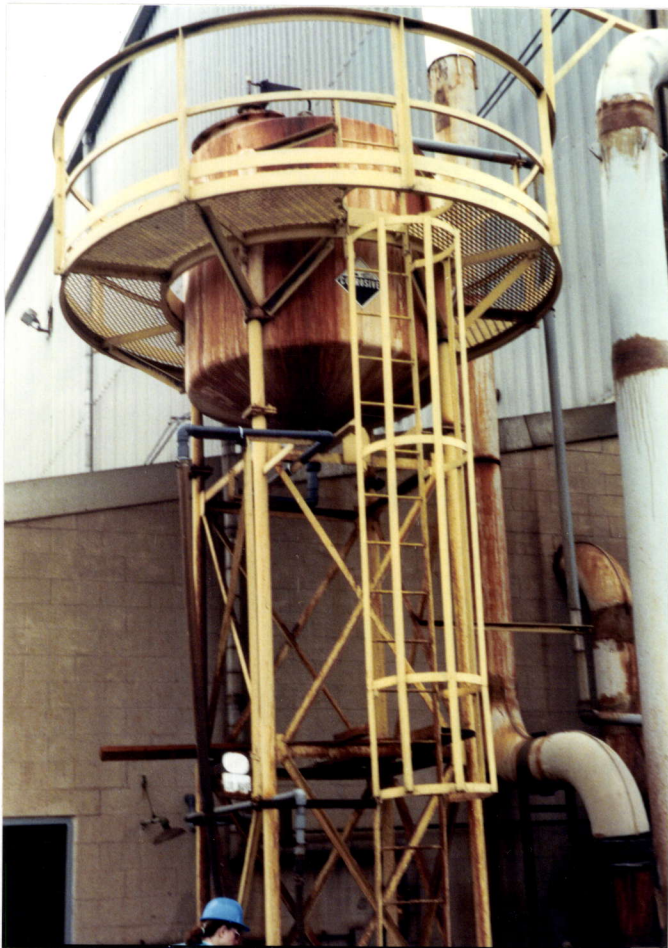
◀
Photograph Number : 20
Photograph Date: 5/21/91
35mm; 400 ASA; Speed: Automatic
Photograph Taken by: Jenna Mead
Photograph Time: 1055 hours
Direction of Photograph: East
Photograph Subject: SWMU No. 15:
Etch Lab holding tank (STA-3).
